## 30-4076-01: Tulsa Metropolitan Utility Authority (TMUA) TMUA ES 2025-06

### Smoke Observation Summary

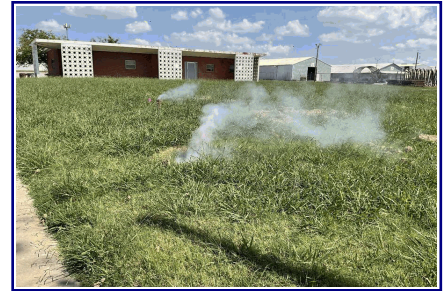
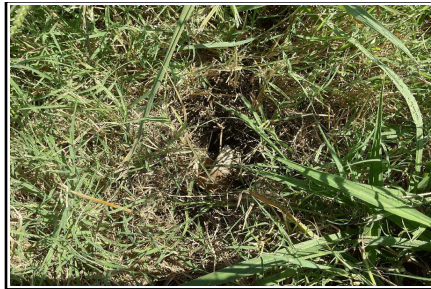
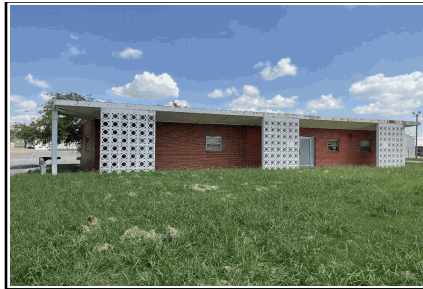
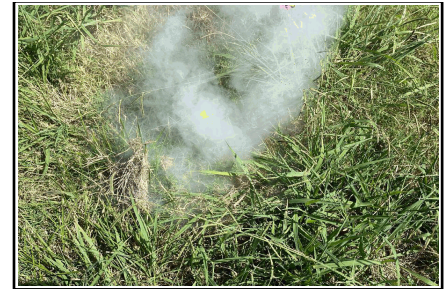
Address: 2921 E Dawson Rd

#### Cleanout, Defective

Intensity: **Medium**

*QC Comments: retake close up showing defect, pull grass back*

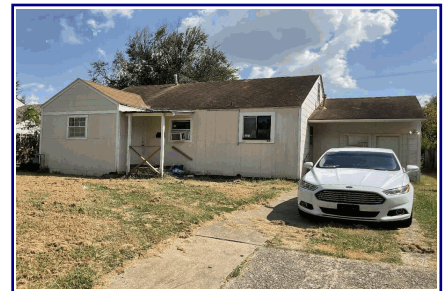
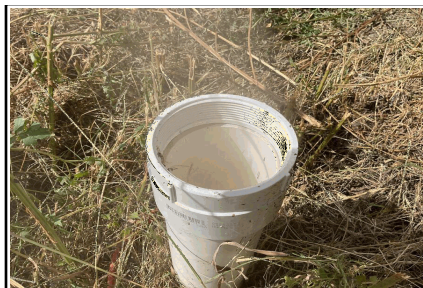
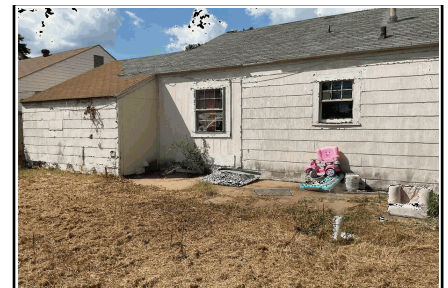
Address: 2708 E Newton Pl

#### Cleanout, Defective

Comments: *Threaded collar broken*

*QC Comments: comment says threaded collar broken, take close up showing broken threaded collar, looks fine in current photo*
