30-4076-01: Tulsa Metropolitan Utility Authority (TMUA) TMUA ES 2025-06

Smoke Observation Summary

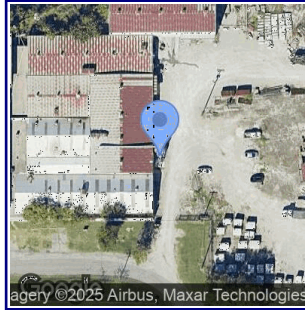
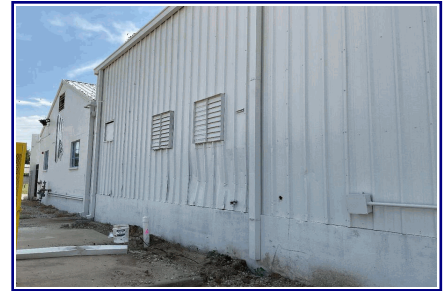
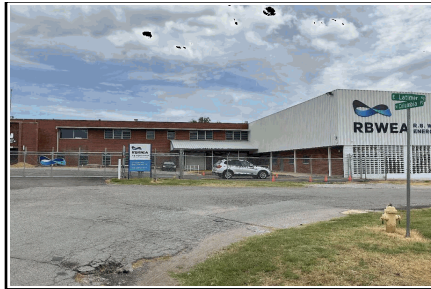
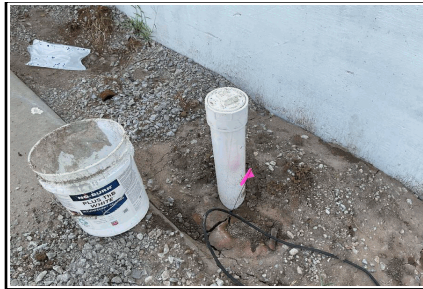
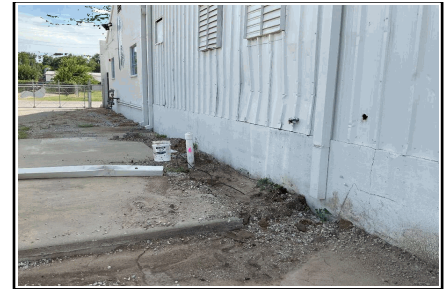
Address: 2735 E Latimer St

Cleanout, Defective

Intensity: **Low**

Surface: **Unpaved**

QC Comments: clarify where smoke is coming from - retake area photo showing roofline

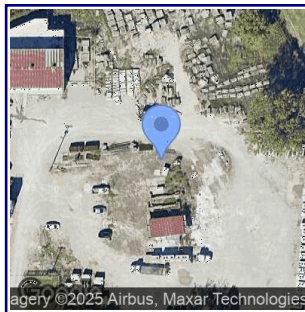
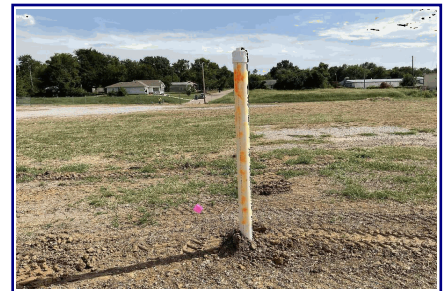
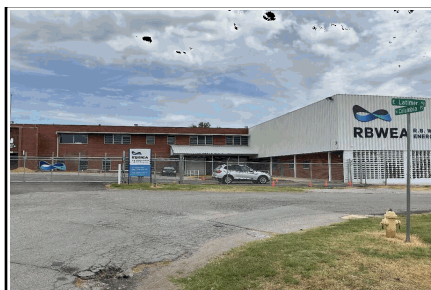
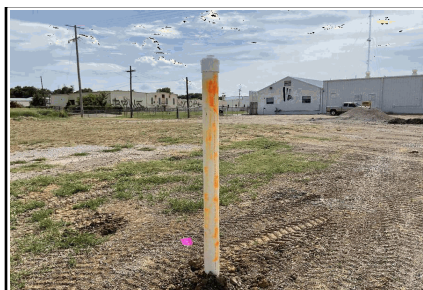
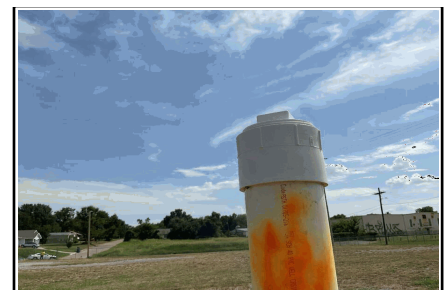
Address: 2739 E Latimer

Cleanout, Defective

Intensity: **Low**

Surface: **Unpaved**

QC Comments: clarify where smoke is coming from
