## 30-4076-01: Tulsa Metropolitan Utility Authority (TMUA) TMUA ES 2025-06

### Smoke Observation Summary

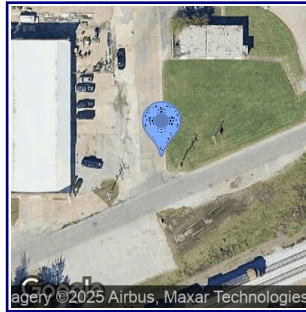
Address: 2921 E Dawson Rd

#### Cleanout, Defective

Intensity: **Medium**

*QC Comments: retake close up showing defect, pull grass back*

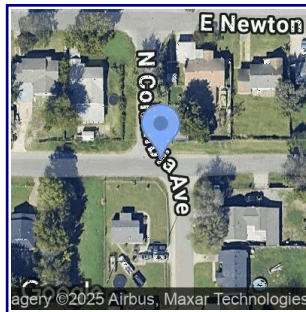
Address: 2708 E Newton Pl

#### Cleanout, Defective

Comments: *Threaded collar broken*

*QC Comments: comment says threaded collar broken, take close up showing broken threaded collar, looks fine in current photo*
